## **Phase II Observations on the Tombs of Rev. John Sergeant (1749) and Abigail Dwight (1791), Town Cemetery, Stockbridge, MA**

By William C. S. Remsen and Ian K. M. Stewart  
September 2023

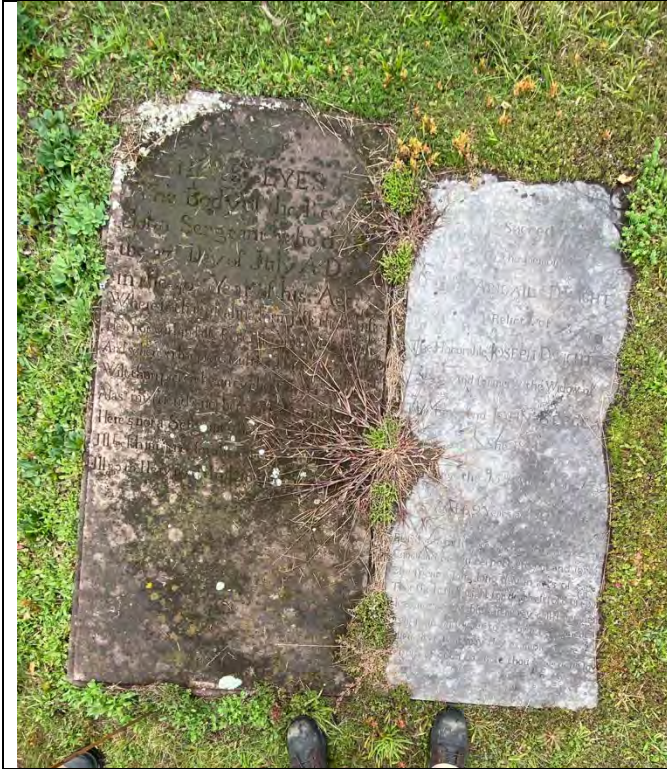
At some unknown date in the distant past, both table tops collapsed. Because the north side of the Reverend's stone rested on top of the southern edge of Abigail Dwight's slab, her table top apparently collapsed first. The direction of collapse was from south to north. It is unclear if there was a chronological gap between the two tombs' collapse or if they failed at essentially the same time.

The numerous very small flakes and fragments of the legs recovered from under the ledger slabs of both tombs support this failure scenario. Both stone slabs ended up with their inscribed tops face up and flush to the ground. There, they languished for decades, exposed to accelerated weathering and biological growths from high moisture levels, from being in contact with the ground, as well as mechanical damage from lawnmowers and people walking directly on the slabs.

Existing conditions of the Rev. Sergeant's and his wife's stone slabs on the ground. (W. Remsen)

2. It is recommended to replace each slab in its original location on top of a new rectangular frame of granite curbing under each slab. The curbing stones would be approximately 6" wide x 12" tall. This would be set back 1/2" from the outer margins of the slabs and would fully support the slabs and keep them above the reach of lawn mowers. The slabs would be slightly sloped to ensure better drainage of rainwater. A 4" gap between slabs would permit cleaning. The original foundation stones would be picked up and reset on top of a layer of crushed stone wrapped in geotextile. This crushed stone would create good drainage under the foundation stones and the curbing, preventing frost heaving and movement.

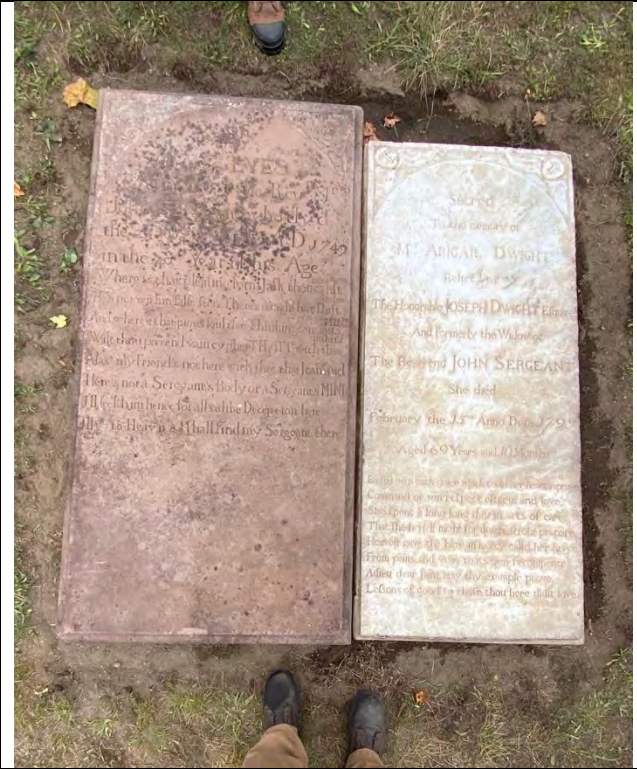
Phase I work included preliminary cleaning. This made the inscriptions legible again. (W. Remsen)

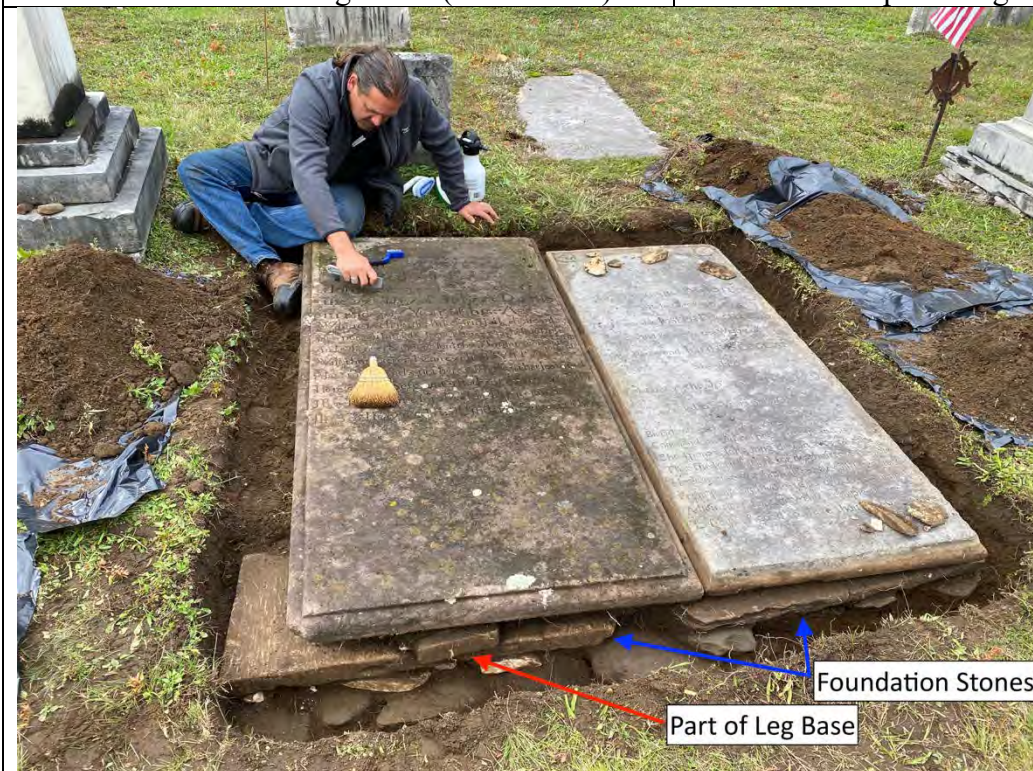
Phase I work included limited excavations around the slabs before cleaning. These revealed marble foundation stones, with stone wedges underneath to level and support them. (W. Remsen)

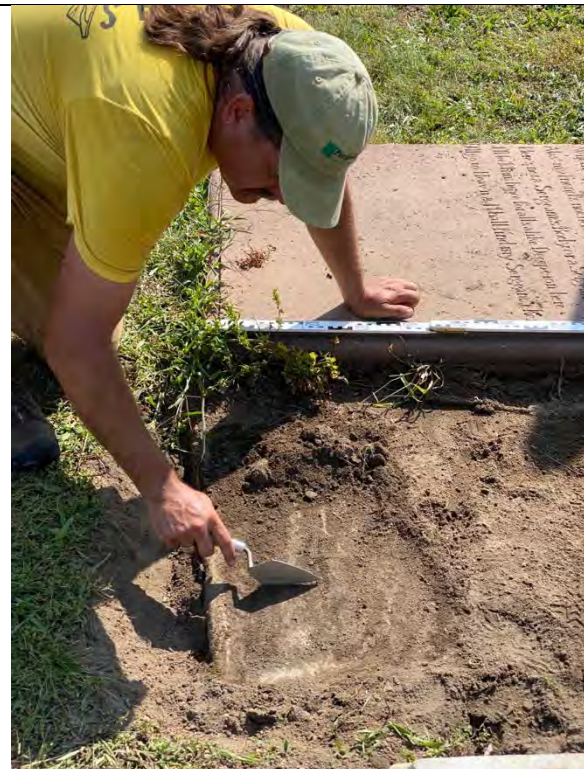
Careful excavations revealed two marble foundation stones. (W. Remsen)

The remains suggest that the legs simply sat on top of the foundation slabs and were held in place by gravity. There may have been small diameter, iron pins at the top. This is not a very stable design.

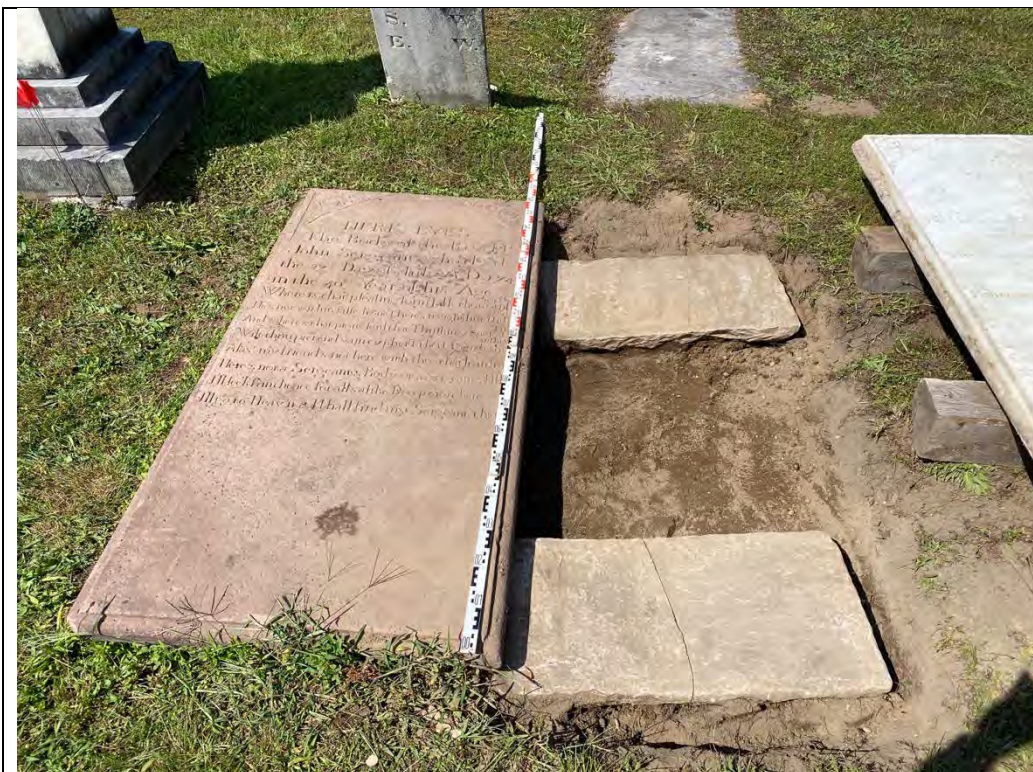
The Abigail Dwight slab is safely sitting on wood sleepers to the right. The foundation stones have been cleaned. The closest foundation stone is cracked in half. (W. Remsen)

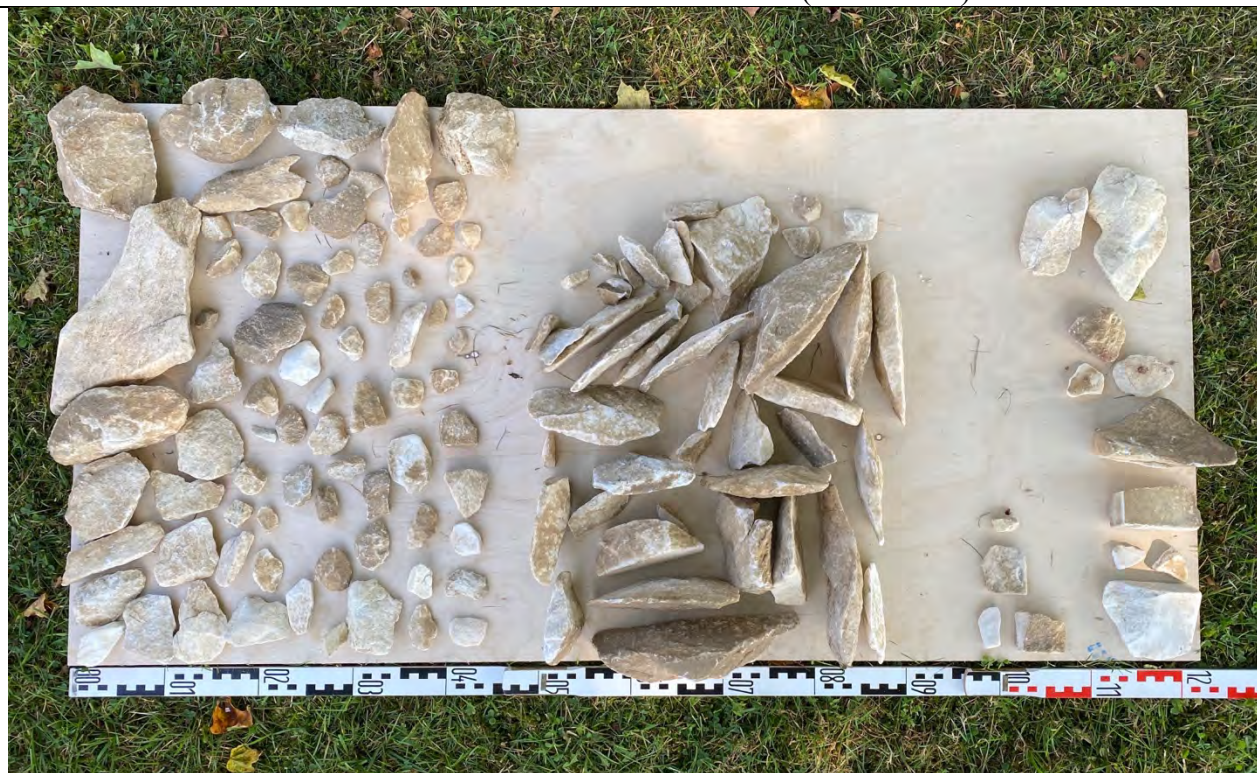
1. The leg fragments came from two types of marble; a pure white marble and a white marble with grey veins. Only a small amount of the grey marble was found.

2. Many fragments were stained from iron in the soil and had 'sugared' weathered surfaces'. These stones were in poor condition.
3. Most of the pieces are rough fragments. Many are conchoidal in shape, suggesting major force was applied rapidly. As there are no traces of impacts, the logical deduction is that the legs were placed in extreme bending, such as when the table tomb racked. When this happened, the upper portion moved while the bases were static. This would change the frame from a rectangle to a rhomboid parallelogram. The bending legs would fail in tension and would essentially explode due to the heavy loads. This single, one-time event would have been very quick and would result in the types of shattered fragments seen.

a. Marble pieces with no finished edges of surfaces.	Quantity	77
b. Marble pieces with one finished surface.	Quantity	41
c. Marble pieces with two finished surfaces.	Quantity	2

d. Marble pieces with three finished surfaces.	Quantity	5
e. Marble pieces with visual traces of 1/4" iron pins	Quantity	3
f. Marble flakes showing weathering associated with iron	Quantity	2
	TOTAL	130

1. The leg remains are far too fragmentary and incomplete to determine the original size and shape of the legs. As there are two foundation stones, there probably were four legs. The single surviving table tomb in the Old Section has six stout marble legs resting on a single massive foundation slab. This is a far more stable design.
2. Even if enough parts to reconstruct one leg survived, the pieces are far too weathered to successfully rebuild any legs.
3. The weathered remains have little informational content and little heritage value.

The leg fragments were cleaned and sorted. From L to R: No finished surface; 1 finished surface; 2 finished surfaces; 3 finished surfaces. Five iron stain stones are in the top right corner. (W. Remsen)

4. The surviving marble leg fragments, which have essentially no informational or heritage value, could be placed inside the appropriate granite frames and covered with the replaced slabs. This would provide a safe and dry location for the fragments and the Town would not need to worry about storing or preserving them. Such things are often thrown away eventually. Thus, the fragments would be securely and respectfully associated with their original tombs and would be available to future researchers if there ever was a need to see them again.

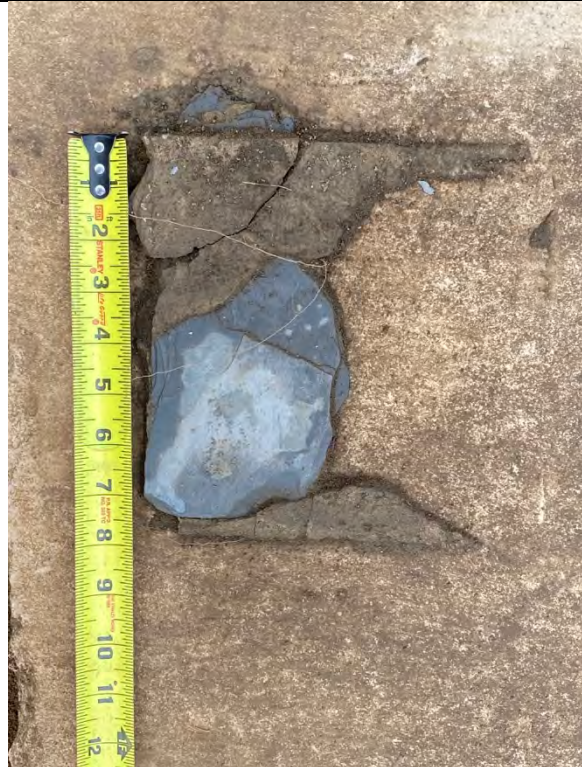
The east foundation stone was roughly carved and measured 35 1/2" x 14 1/4" x ~2 1/2". On top of it survived traces of cement mortar and slate shims which had apparently been used to support and level the tomb's legs. The mortar must have been made from a natural cement, as it is darker and far harder than a pure lime mortar. The mortar traces showed that the leg bases were square and 8" on a side. This exactly fit the surviving leg base fragment. The 8" x 8" bases were set 4" in from the short sides and 11" apart.

The east foundation stone retained traces of the slate and cement leg base support. (W. Remsen)

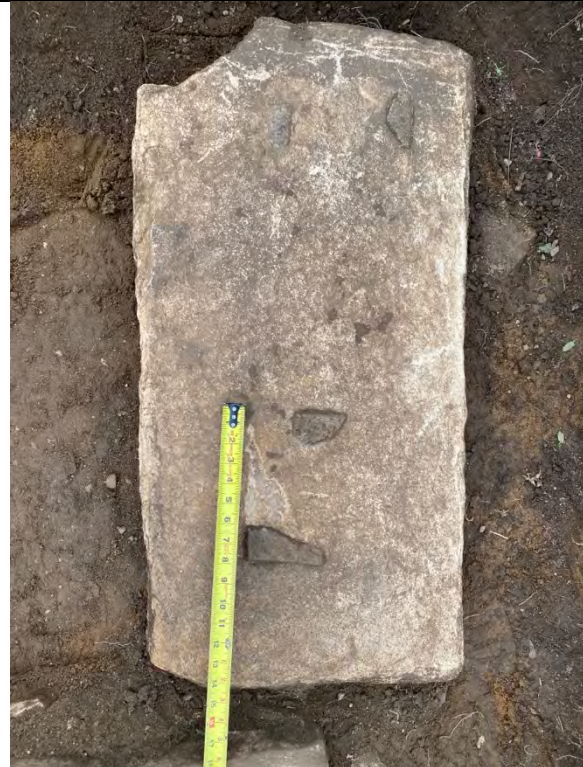
The west foundation stone was roughly carved and measured 35" x 17" x ~3". This was 1" wider on the south side. There also were traces of 8" x 8" mortar on top of this foundation stone. The 8" x 8" bases were set 4" in from the short sides and only 8 1/5" apart. The unequal spacing between the legs on the east and west foundation stones would have made the tomb somewhat unstable. This apparently was an error in the original design and/or installation.

The west foundation stone also showed traces of the cement mortar bedding for legs. (W. Remsen)

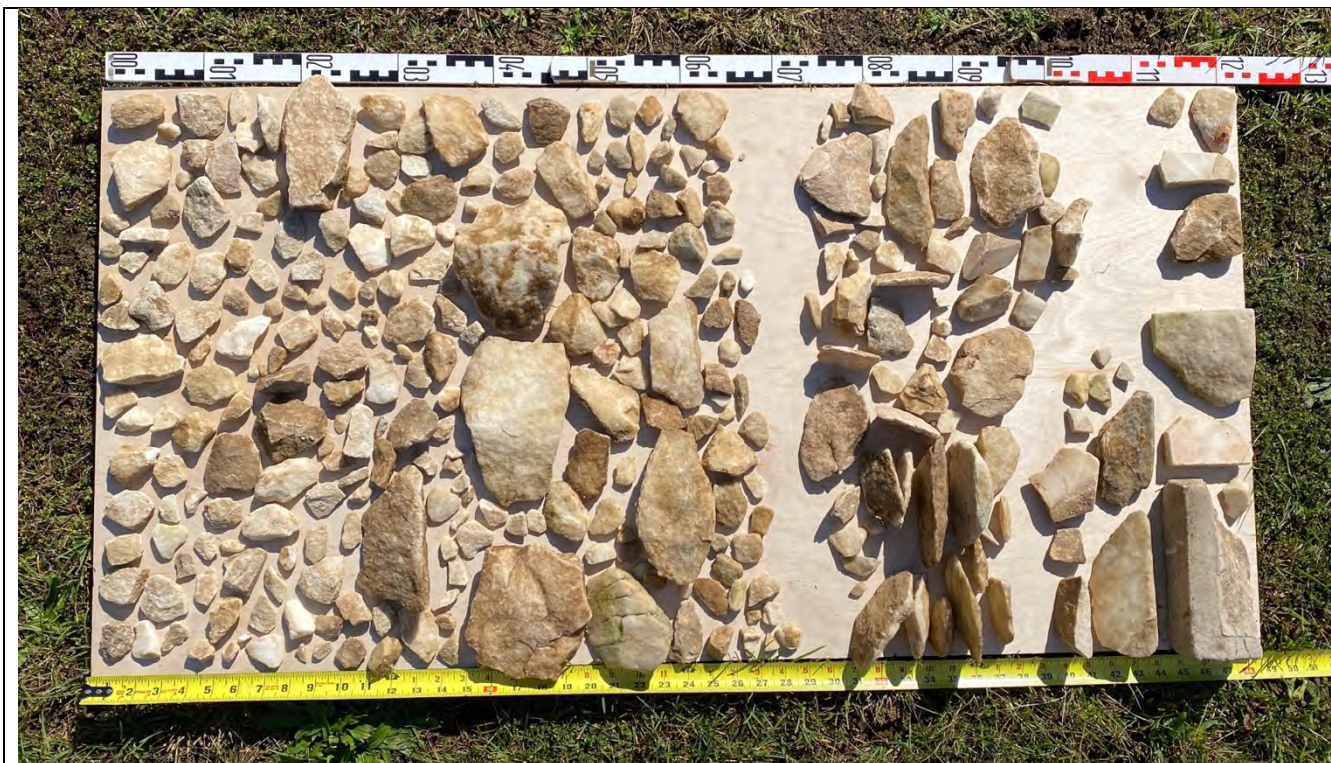
1. Some fragments were stained from iron in the soil and had 'sugared' weathered surfaces'. These stones were in poor condition.
2. Most of the pieces are rough fragments. many are conchoidal in shape, suggesting major force was applied. As there are no traces of impacts, the logical deduction is that the legs were placed in extreme bending, such as when the table tomb would rack. The legs would fail in tension and would essentially explode. This single, one-time event would have been very quick and would result in the types of shattered fragments seen.
3. The marble leg fragments can be organized as follows:

a. Marble pieces with no finished edges of surfaces.	Quantity	241
b. Marble pieces with one finished surface.	Quantity	61
c. Marble pieces with two finished surfaces.	Quantity	11

d. Marble pieces with three finished surfaces.	Quantity	4
e. Marble pieces with visual traces of iron pins	Quantity	3
f. Marble flakes showing possible decoration	Quantity	1
	TOTAL	321

1. The leg remains are far too fragmentary and incomplete to determine the original size and shape, and even the number of legs, although four legs is probable based on the foundation stones.
2. Even if enough parts to reconstruct one leg survived, which they do not, the pieces are far too weathered to successfully rebuild any legs.
3. The remains have little informational content and little heritage value, except for the one substantial leg base fragment found. This should be retained and archived.

The leg fragments were cleaned and sorted. From L to R: No finished surface; 1 finished surface; 2 finished surfaces; 3 finished surfaces. Three iron stain stones are in the top right corner. (W. Remsen)

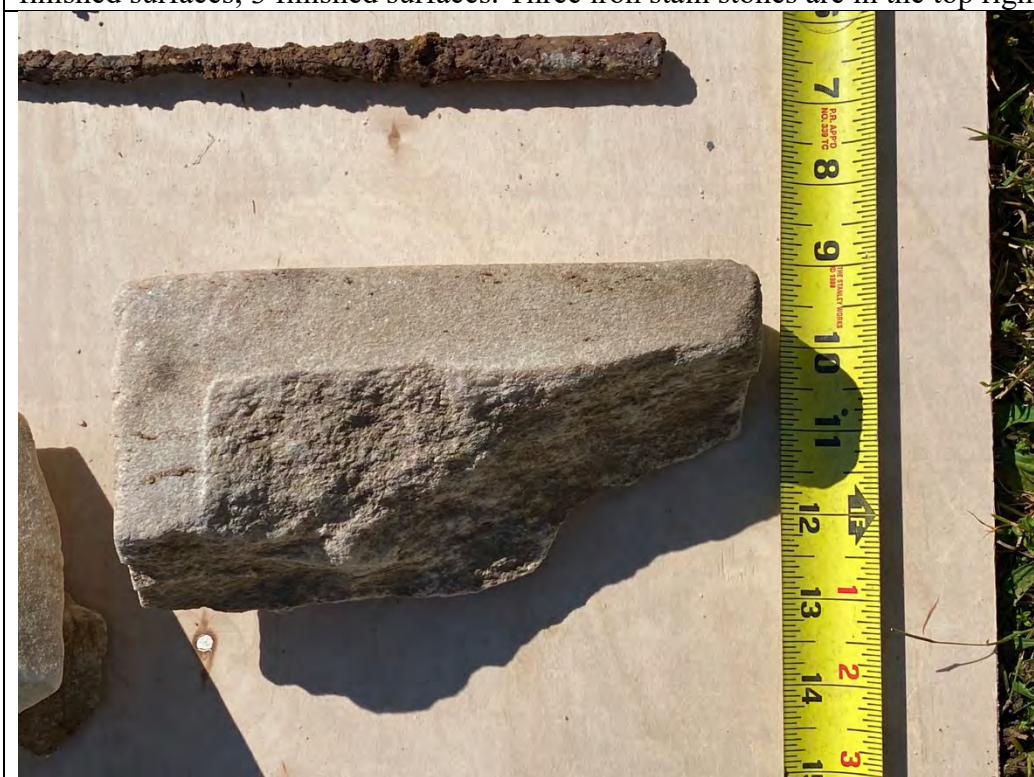
Once the slab was lifted, the tops of the two foundation stones and the adjacent areas were carefully excavated and cleaned. This revealed additional marble leg fragments including one important piece which apparently is most of the base of one leg. This fragment had been noted in the Phase I excavations, but the fragment had been left in place until the slab was lifted.

This is the leg base fragment from under the Rev. John Sergeant slab. It is the only leg fragment with any significant informational value and should be retained. (W. Remsen)

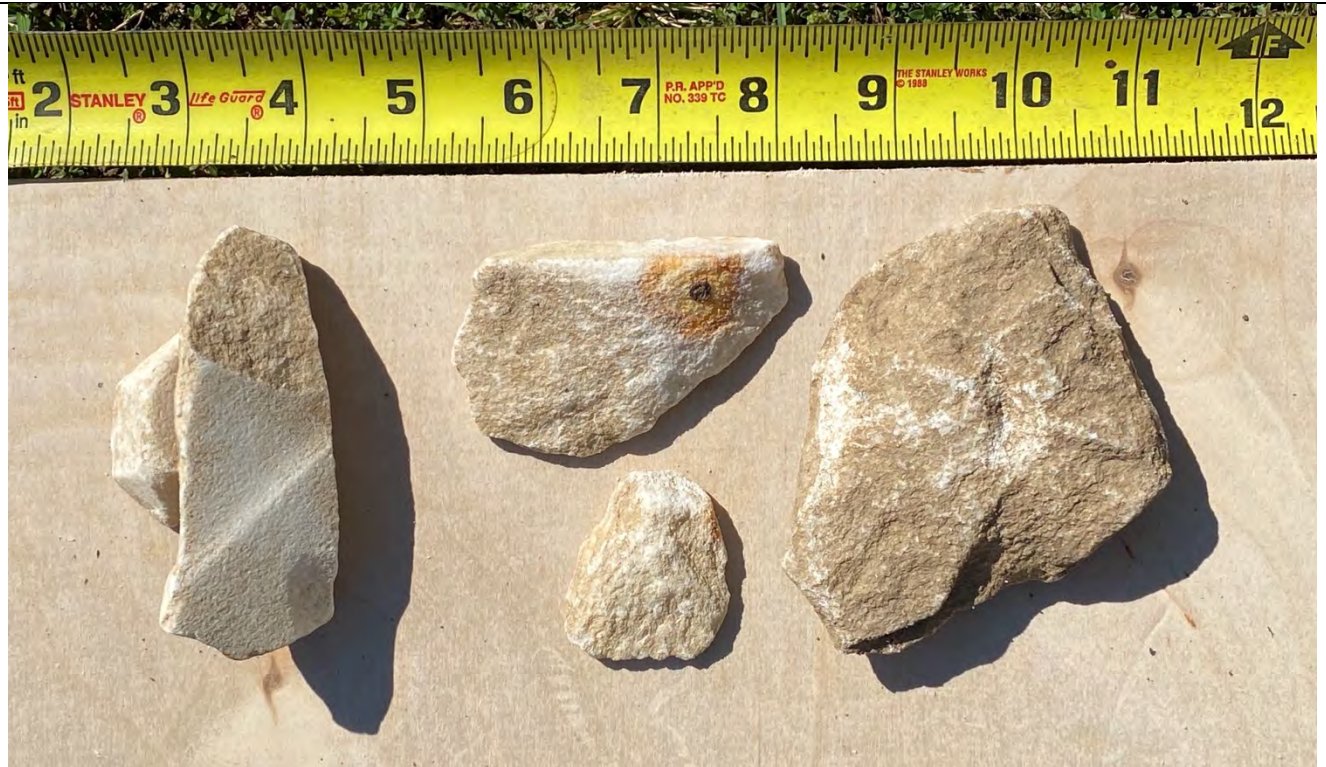
No traces of mortises and tenons or iron pins were found in the leg bases. Traces of small diameter iron pins were found in several marble fragments; they may have been from the leg top/slab junctions.

One marble fragment showed a finished surface with possible decoration. This may also have simply been where two saw cuts were slightly misaligned.

Three marble fragments (right) from under the Rev. Sergeant slab showed traces of iron pins. The fragment on the left shows a finished surface with possible decoration. (W. Remsen)

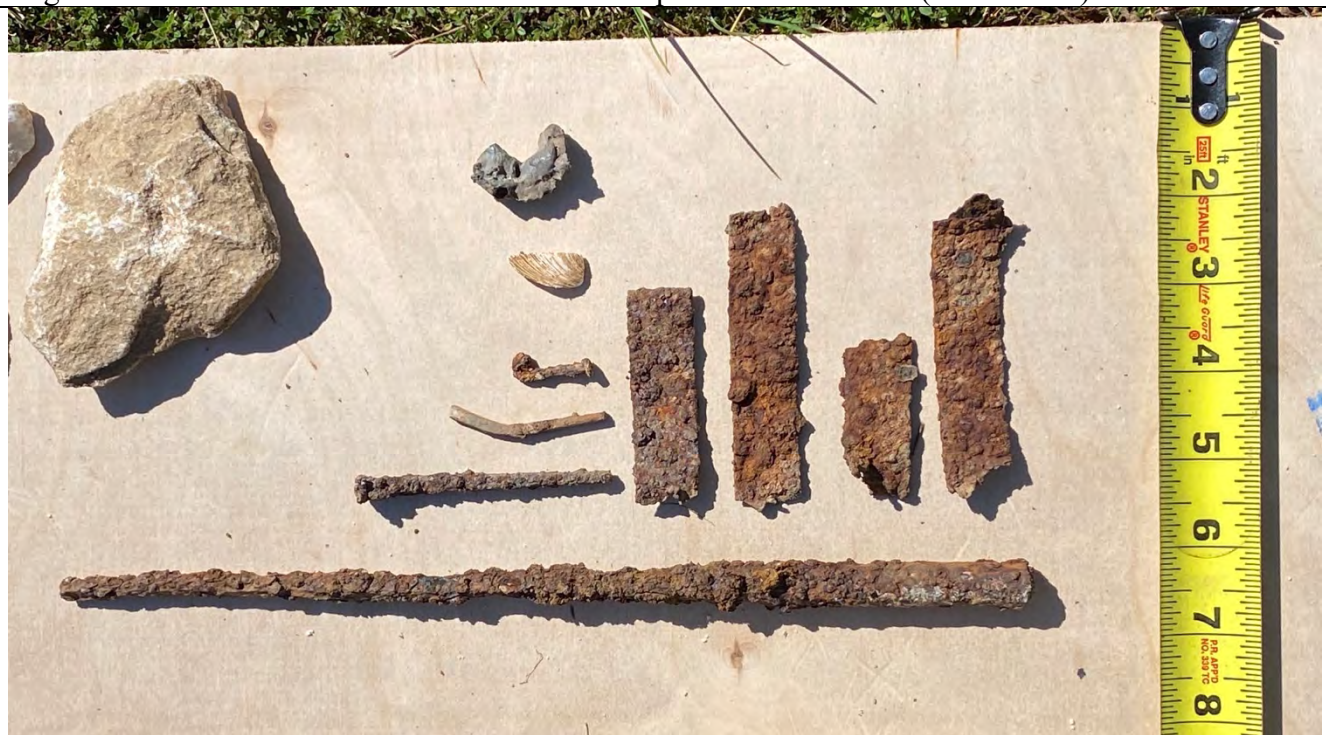
Additional finds included one 12" long, heavily rusted, iron object, several iron nails and lengths of flat iron straps. Several pieces of coal slag (clinker) were found. A single unworked fragment of quahog clam (*Mercenaria mercenaria*) was found. These mollusks were used by Native Americans to make wampum beads. These miscellaneous materials seem unrelated to the graves and may indicate that even in the mid 18th century this area was disturbed land with debris mixed in from various periods and activities.

Objects found under the Rev. Sergeant slab included three iron nails, iron strapping, a long iron object, a piece of clam shell, and coal slag. These objects seem unrelated to the burial. (W. Remsen)
