# MASSACHUSETTS DEPARTMENT OF TRANSPORTATION PAGE 1 OF 17

#### **STRUCTURES INSPECTION FIELD REPORT** BR. DEPT. NO. 2-DIST B.I.N. **ROUTINE INSPECTION** 02M 01 S-26-004 CITY/TOWN 8 -STRUCTURE NO 11-Kilo. POINT 90-ROUTINE INSP. DATE 41-STATUS A:OPEN STOCKBRIDGE S26004-02M-MUN-NBI 000.000 JUN 28, 2022 07-FACILITY CARRIED MEMORIAL NAME/LOCAL NAME 27-YR BUILT 106-YR REBUILT YR REHAB'D (NON 106) HWY GLENDALE MDL 1978 0000 0000 06-FEATURES INTERSECTED DIST. BRIDGE INSPECTION ENGINEER 26-FUNCTIONAL CLASS L. A. Briggs **Urban Minor Arterial** WATER HOUSATONIC RIVER TEAM LEADER M. P.E. McCabe 21-MAINTAINER 22-OWNER 43-STRUCTURE TYPE 505 : Prestressed Concrete Box Beam or Girders -Town Agency Town Agency Michael PE McCabe Multiple TEAM MEMBERS 107-DECK TYPE WEATHER TEMP. (air) G. A. KOTSKI, M. RANZONI 2 : Concrete Precast Panels Sunny 24°C ITEM 59 ITEM 58 ITEM 60 5 5 6 SUPERSTRUCTURE SUBSTRUCTURE DECK DEF DEF DEF 1. Abutments Dive Cur 5 S-A 1.Stringers Ν 6 1.Wearing Surface \_ a. Pedestals Ν 2.Floorbeams Ν Ν -2. Deck Condition 5 S-A b. Bridge Seats Ν н -3. Floor System Bracing Ν Ν 3.Stay in Place Forms -c. Backwalls Ν н 5 4. Girders or Beams S-A d. Breastwalls 6 6 M-P 6 4.Curbs e. Wingwalls

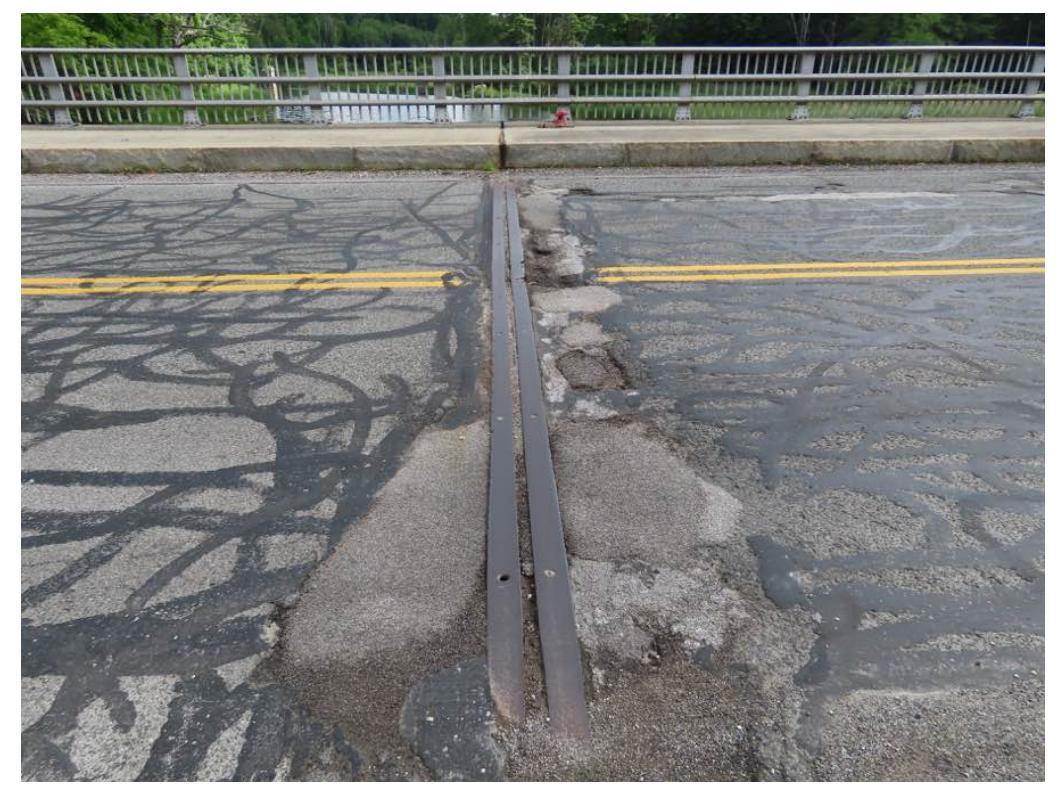
The wearing surface has widespread sealed mapcracking. Along the longitudinal beam joints, there are sealed reflective cracks. See photo 3.

Photo 3: General overview of the wearing surface, looking west.
