## **Phase II Observations on the Tombs of Rev. John Sergeant (1749) and Abigail Dwight (1791), Town Cemetery, Stockbridge, MA**

By William C. S. Remsen and Ian K. M. Stewart  
September 2023

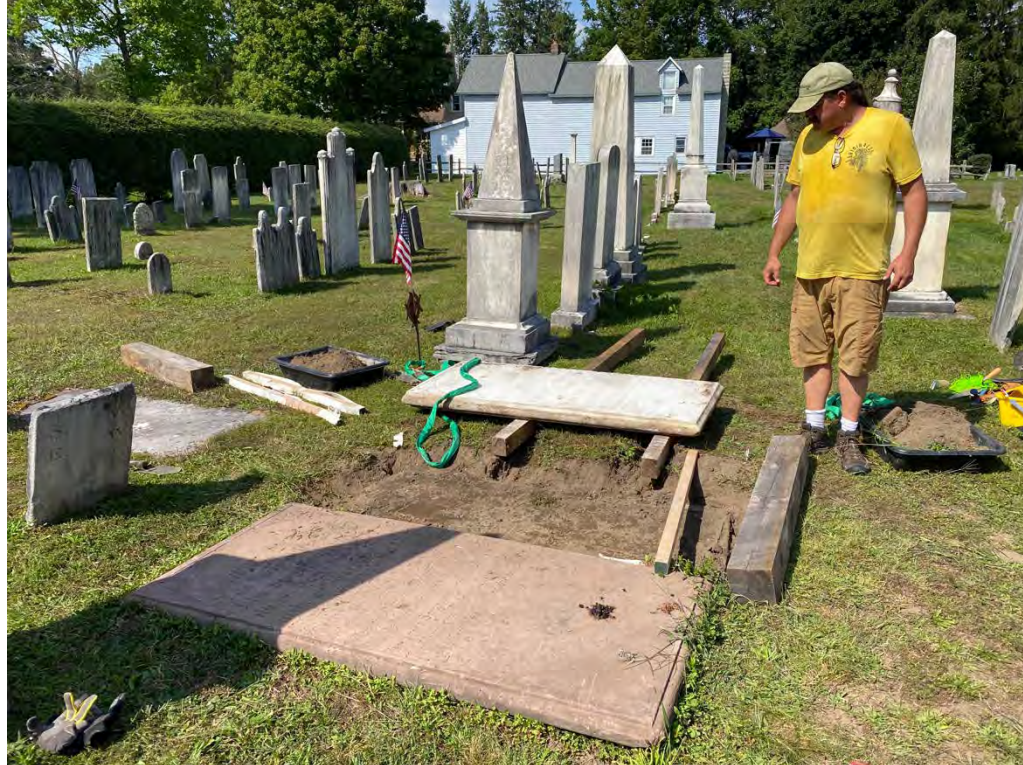
The Abigail Dwight slab is in the process of being moved away from its original location. (W. Remsen)

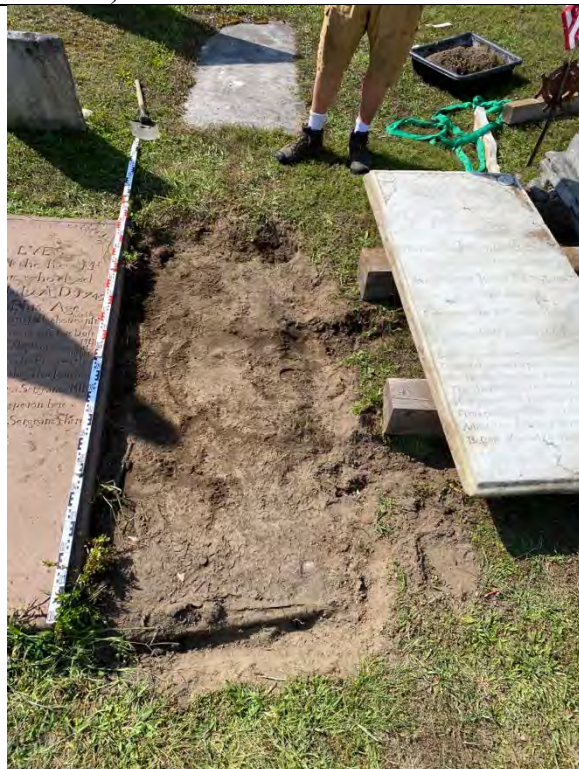
Initially only dirt could be seen under the Abigail Dwight slab. (W. Remsen)

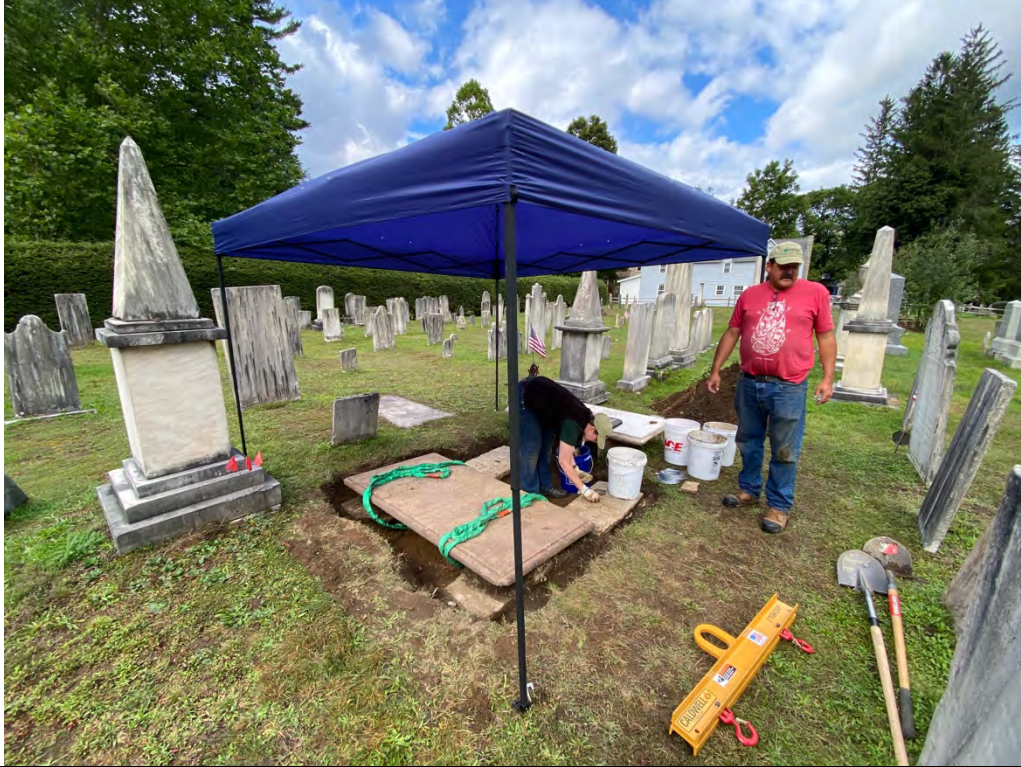
The Abigail Dwight foundation stones are being cleaned and the green nylon lifting straps are being placed under the Rev. John Sergeant slab prior to lifting. (W. Remsen)

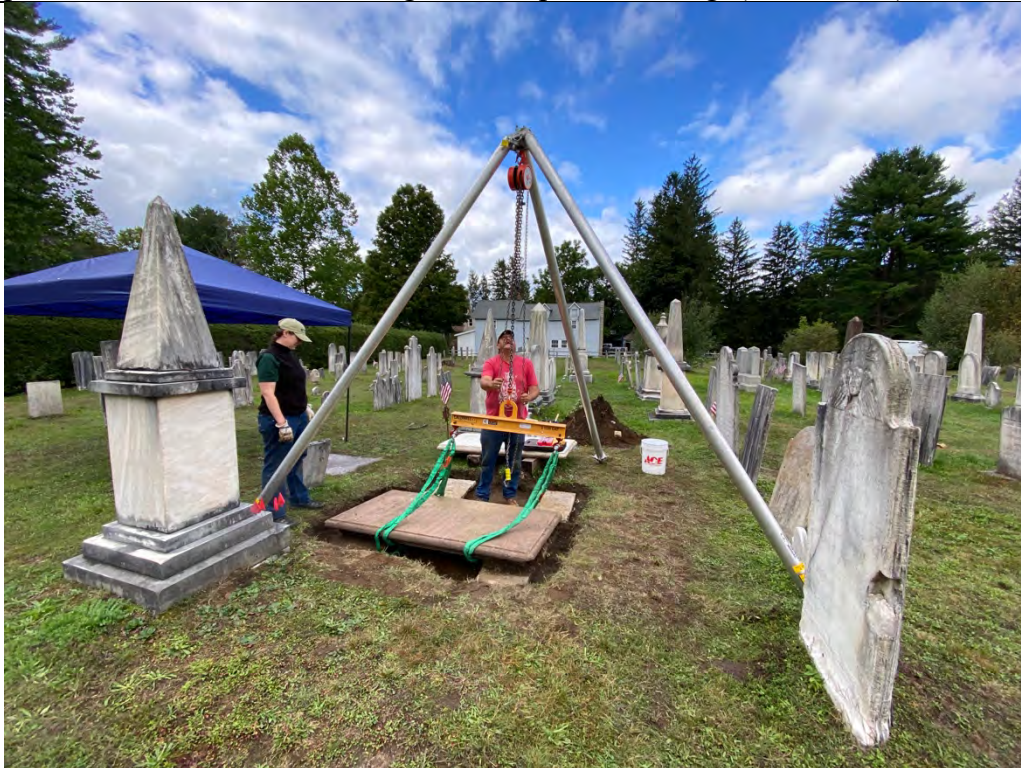
The 4,000 pound capacity tripod and chain pull are being used with a steel load spreader to evenly lift the Rev. John Sergeant slab. (W. Remsen)

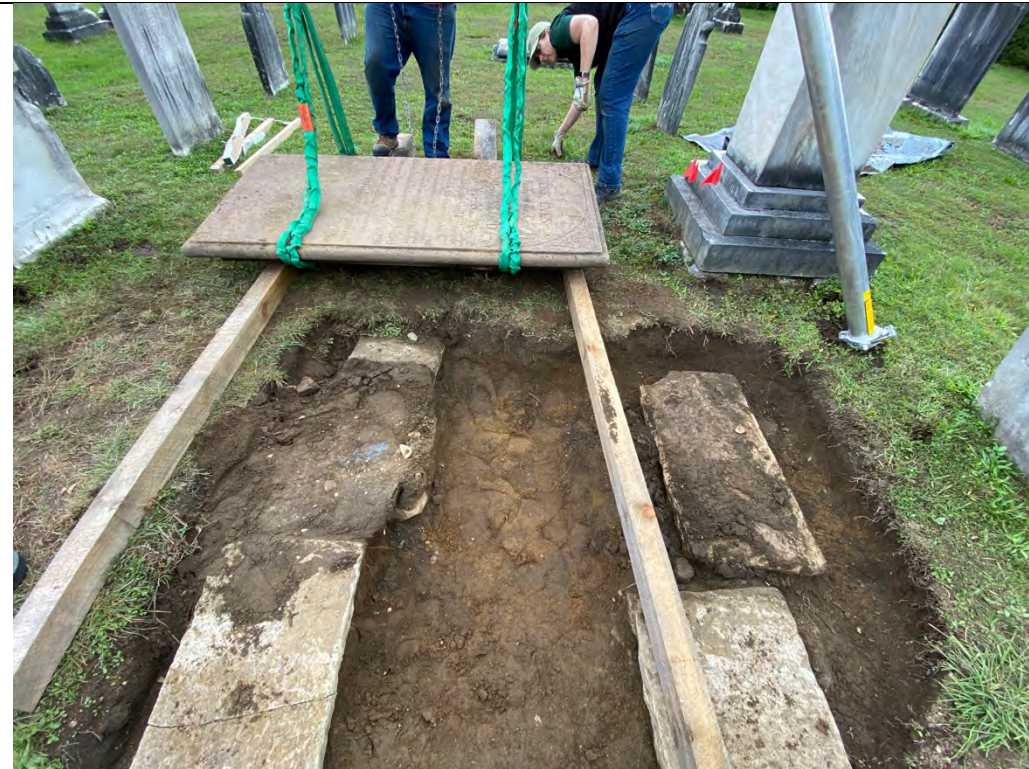
The Rev. Joh Sergeant slab has been lifted off the two marble foundation stones, which remain to be cleaned. (W. Remsen)

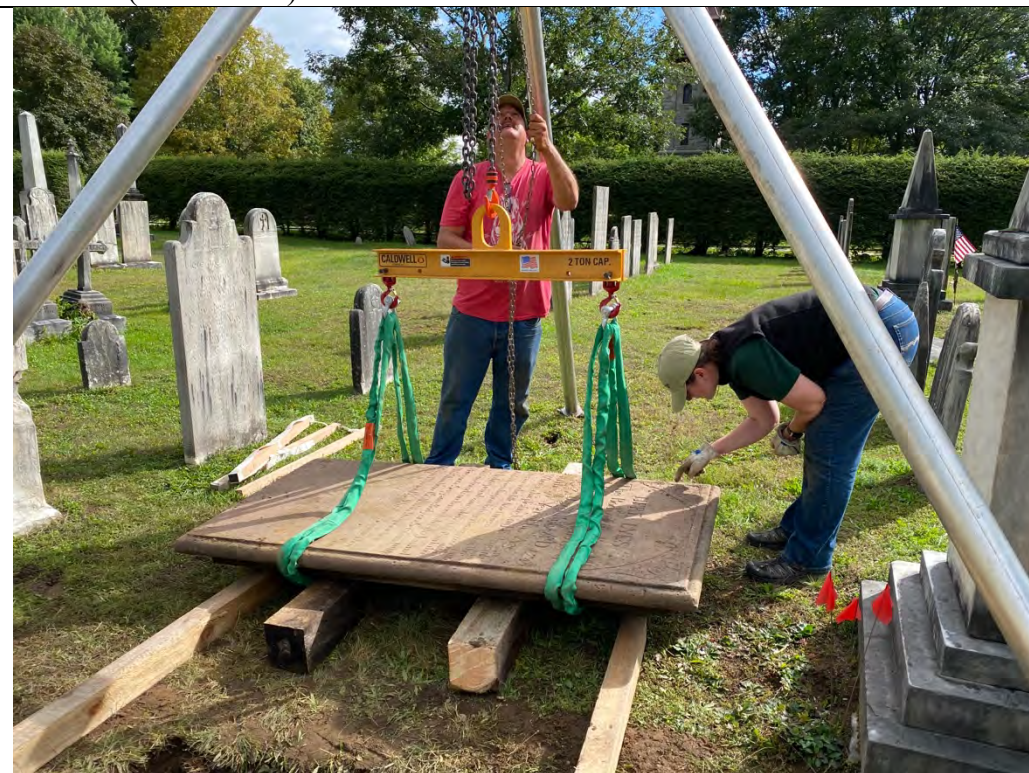
Ian Stewart is carefully lowering the slab onto the wood sleepers. (W. Remsen)

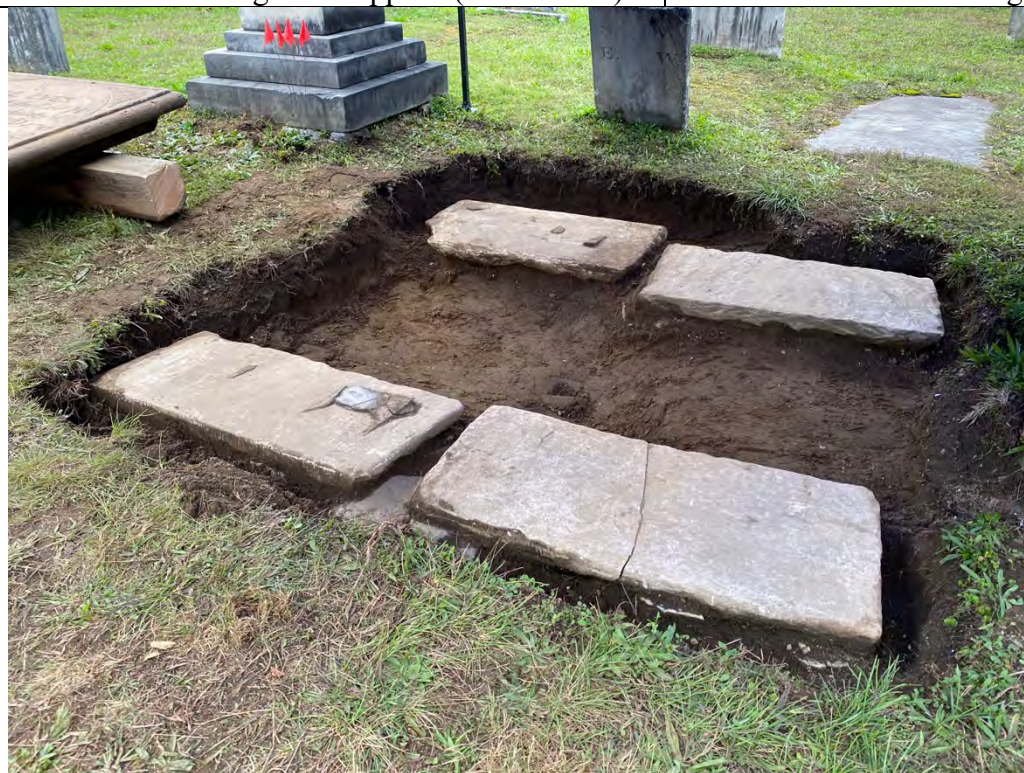
The foundation stones for both slabs are cleaned. Rev. Joh Sergeant slab foundation stones are on the left. The two slabs are safely sitting on 10" x 10" wood sleepers nearby. (W. Remsen)
