# MASSACHUSETTS DEPARTMENT OF TRANSPORTATION PAGE 1 OF 17

#### **STRUCTURES INSPECTION FIELD REPORT** BR. DEPT. NO. 2-DIST B.I.N. **ROUTINE INSPECTION** 02M 01 S-26-004 CITY/TOWN 8 -STRUCTURE NO 11-Kilo. POINT 90-ROUTINE INSP. DATE 41-STATUS A:OPEN STOCKBRIDGE S26004-02M-MUN-NBI 000.000 JUN 28, 2022 07-FACILITY CARRIED MEMORIAL NAME/LOCAL NAME 27-YR BUILT 106-YR REBUILT YR REHAB'D (NON 106) HWY GLENDALE MDL 1978 0000 0000 06-FEATURES INTERSECTED DIST. BRIDGE INSPECTION ENGINEER 26-FUNCTIONAL CLASS L. A. Briggs **Urban Minor Arterial** WATER HOUSATONIC RIVER TEAM LEADER M. P.E. McCabe 21-MAINTAINER 22-OWNER 43-STRUCTURE TYPE 505 : Prestressed Concrete Box Beam or Girders -Town Agency Town Agency Michael PE McCabe Multiple TEAM MEMBERS 107-DECK TYPE WEATHER TEMP. (air) G. A. KOTSKI, M. RANZONI 2 : Concrete Precast Panels Sunny 24°C ITEM 59 ITEM 58 ITEM 60 5 5 6 SUPERSTRUCTURE SUBSTRUCTURE DECK DEF DEF DEF 1. Abutments Dive Cur 5 S-A 1.Stringers Ν 6 1.Wearing Surface \_ a. Pedestals Ν 2.Floorbeams Ν Ν -2. Deck Condition 5 S-A b. Bridge Seats Ν н -3. Floor System Bracing Ν Ν 3.Stay in Place Forms -c. Backwalls Ν н 5 4. Girders or Beams S-A d. Breastwalls 6 6 M-P 6 4.Curbs e. Wingwalls

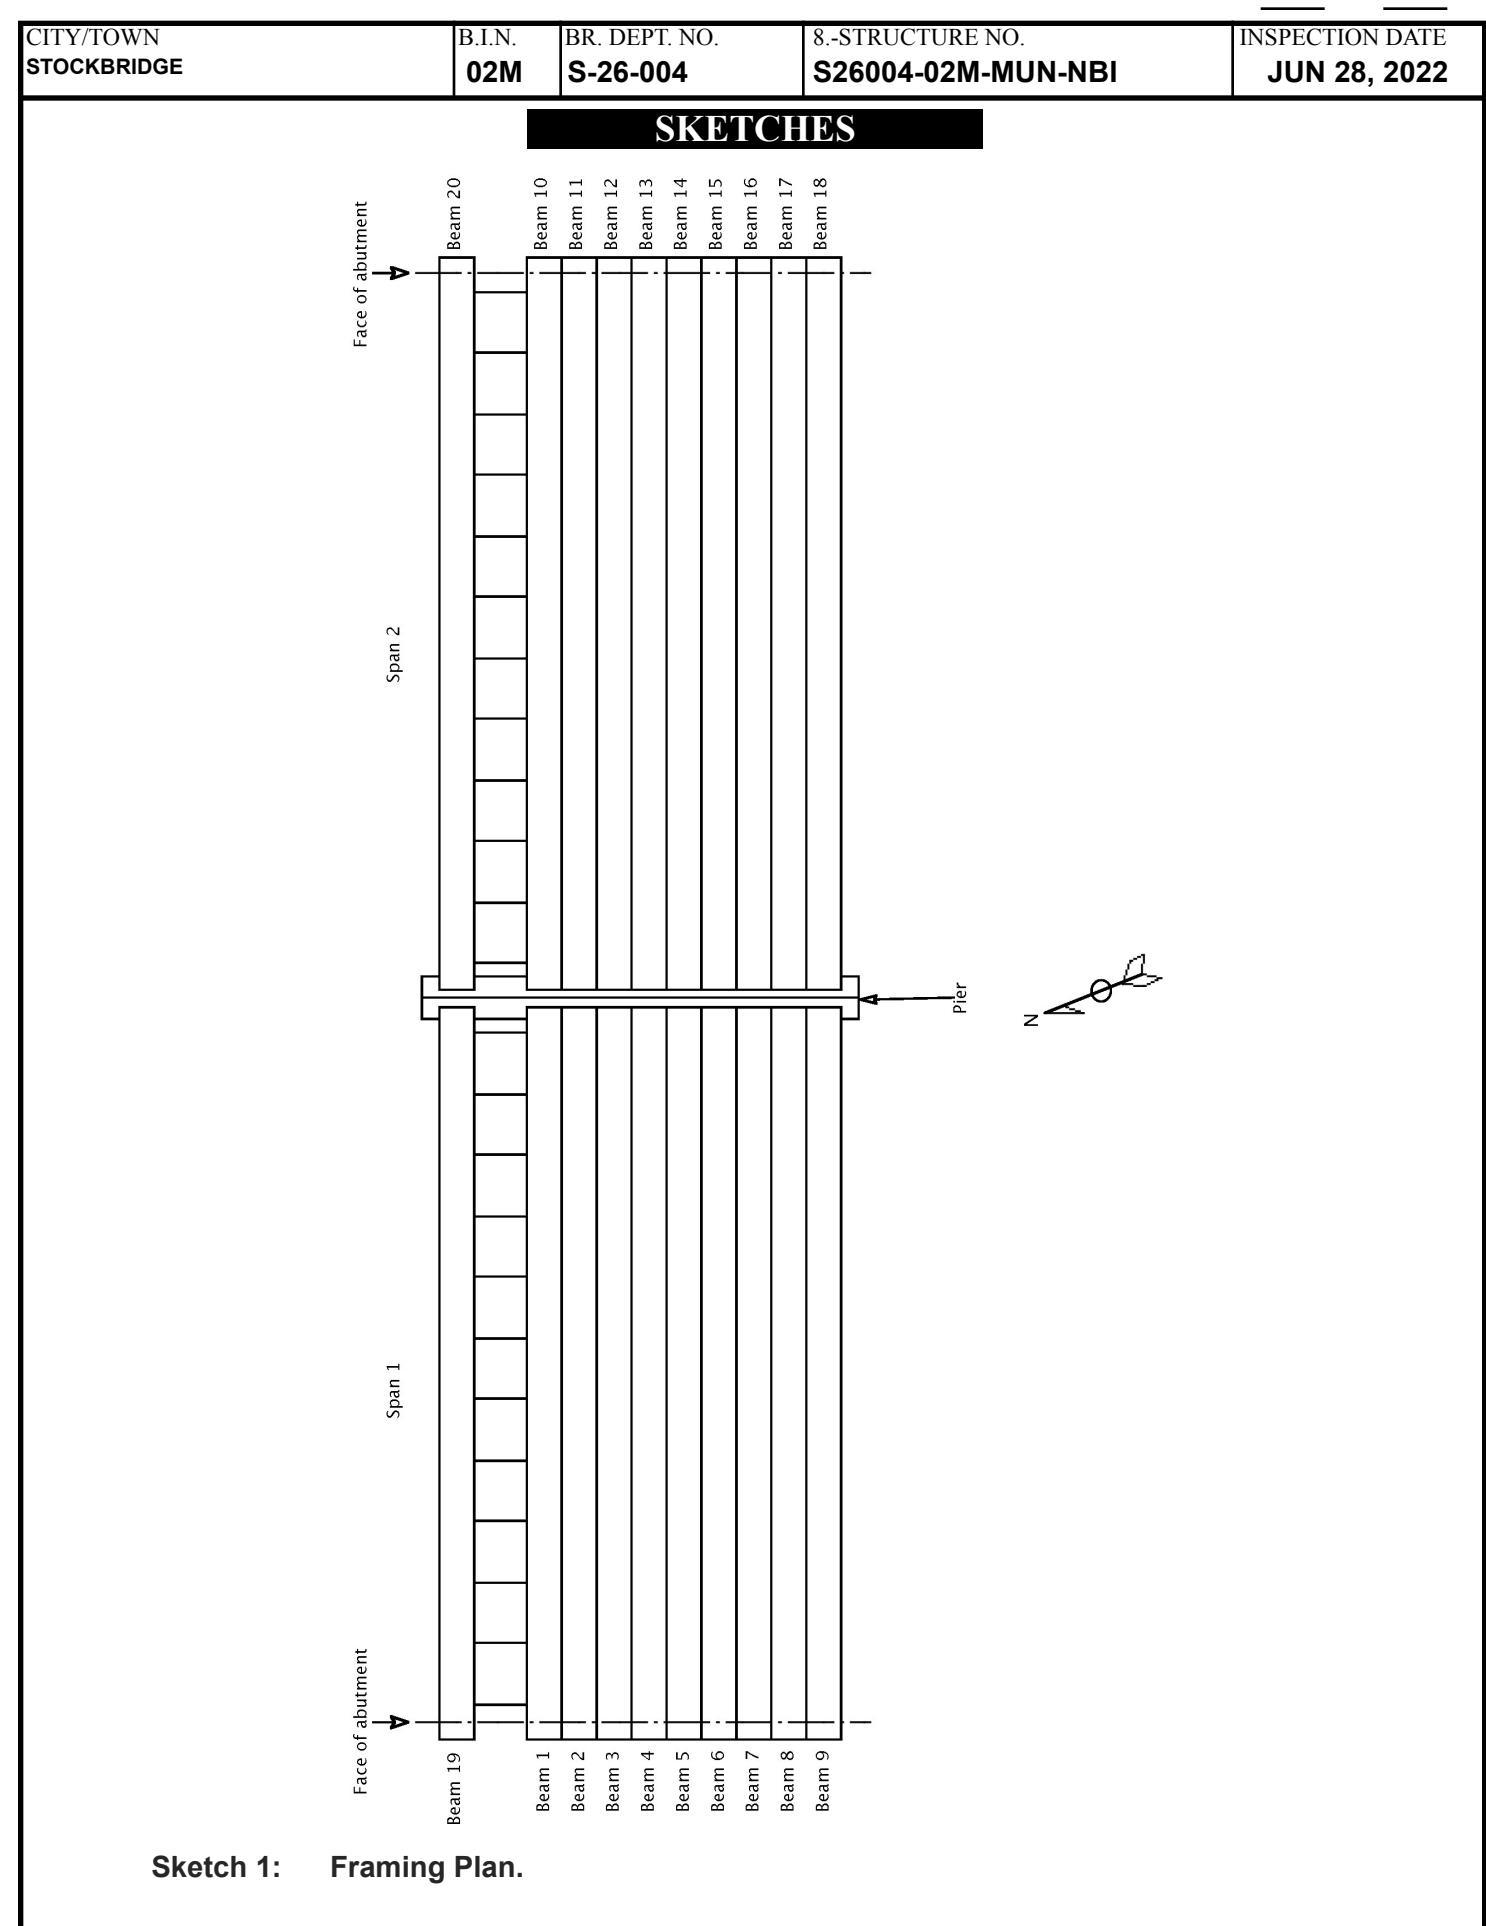
CITY/TOWN		B.I.N.	BR. DEPT. NO.	8STRUCTURE NO.	INSPECTION DATE					
STOCKBRIDGE		02M	S-26-004	S26004-02M-MUN-NBI	JUN 28, 2022					
			REMA	RKS						
The northeast steel terminal end has been replaced since the previous Routine Inspection Report. See photo 14.										
Sketch / Pho	to Log									
Sketch 1 :	Framing Plan.									
Photo 1 :	General topside, le	ooking	west.							
Photo 2 :	Typical underside,	, lookir	ng west (span 2 s	hown).						
Photo 3 :	General overview	of the	wearing surface,	looking west.						
Photo 4 :	Patches and pothe	oles al	ong the pier joint	armor.						
Photo 5 :	Dirt and debris in t	n the east joint. Note the damaged seal at the south end. Also, note the								
	patches and pothe	oles alo	ong the armor.							
Photo 6 :	Low scupper in the	the east approach, along the south curb. Also, note the rot visible on the top of								
	the transition and	approa	ach guardrail pos	ts.

Photo 7 :	Northeast approac	ch side	walk settlement.							
Photo 8 :	Beams 7 & 8 spall	ling, lo	oking west. Note	the exposed prestressing stra	ands.					
Photo 9 :	Spalling on the so	uth fac	ce of the pier cap.	Also, note the end spalling o	f beam 9 and the					
	undermining of be	earing ?	18.							
Photo 10 :	Overall view of spa	alling i	n beam 15, lookii	ng west.						
Photo 11 :	Close view of the	expose	ed prestressing s	trands in beam 15 (typical).						
Photo 12 :	Cracking, rust stai	ining, s	spalls along the to	op of the west abutment, south	ı half.					
Photo 13 :	Overall view of the	e pier,	east face.							
Photo 14 :	New approach gua	ardrail	end treatment at	the northeast corner.
